**CAMPION HOUSE, HOUNSLOW,
GREATER LONDON**

ECOLOGICAL ASSESSMENT

Final Document

March 2008

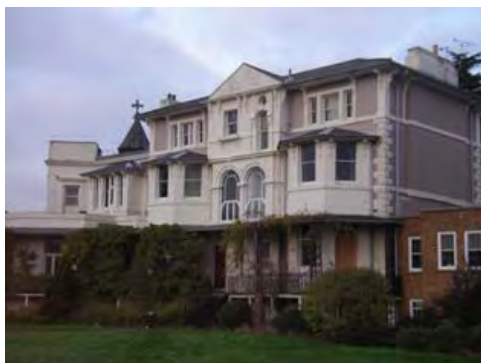
Figure 1 Western Elevation of Building A

Building A was built during the 1800's and although it will not be demolished as part of the proposed development it was assessed for the presence of bats. The main three storey building has a hipped roof with two dormer type windows facing west and east. To the north, the building is two storeys with a flat roof and a circular wooden slatted bell tower with a conical slate roof. Attached to the north of this is a single storey flat roofed building (Figures 1-4).

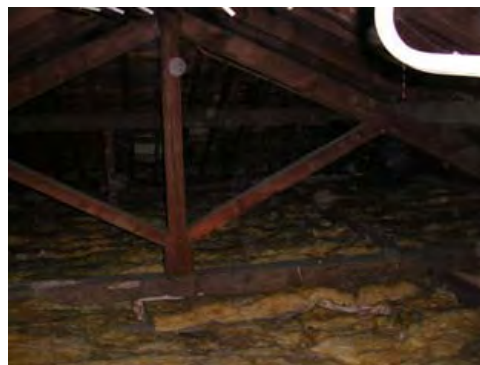
Figure 4 Roof Void in Building A

Internally the main three storey building has a roof void that is of king post construction with a felt lining beneath the tiles. During the surveys no evidence of bat activity was recorded within the roof void of the building. The roof void of the bell tower was also investigated, and again no evidence of the presence of bats was recorded. Externally the building appeared to be in a good state of repair, providing few opportunities for bat access. However, it was difficult to assess the roof due to the height of the building.

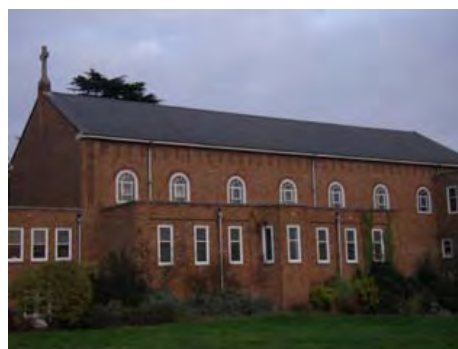
Figure 5 Building B

This is a large 'L' shaped, brick built building with a pitched roof of gable end design and a single storey flat roofed building that projects in a westerly direction (Figure 5). There is no accessible roof void in this building; however the interior of the roof is semi-circular suggesting that there is a small space between the ceiling and roof. An external examination of the building failed to find any evidence of bats or any potential bat access points. The brickwork and roof tiles appear to be in a good state of repair. However, the height of the building made it difficult to assess fully. It is considered unlikely that this building supports a population of bats.

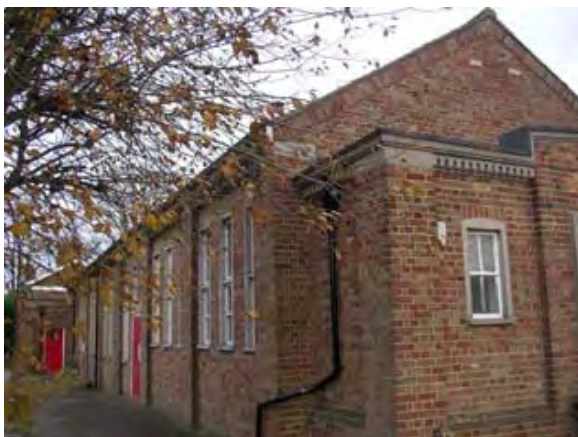
Figure 9 Building D

This is a long brick built building with a pitched, gable ended roof. Soffit boxes run along the length of the northern and southern elevation of the building (Figures 9 and 10). Internally there is no roof void as the room extends into the roof space and the underside of the roof is clad with wood. Where the soffit box meets the main building wall on the northern elevation a large gap has formed offering ample access for bats. At the south-eastern corner of the building the end of the soffit box is open offering potential access to bats.

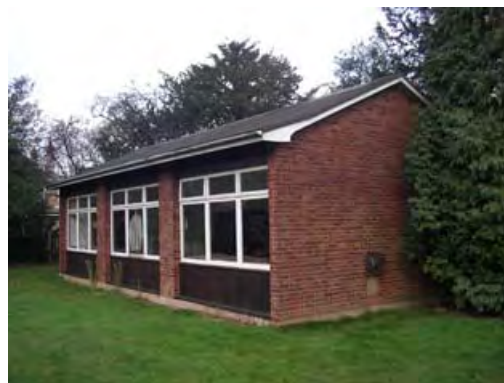
Figure 11 Building E

This building is a brick built design with a pitched felt roof. The western elevation of the building consists of windows surrounded by wood cladding, interspersed with brick supporting posts. The eastern elevation is brick and heavily shaded by shrubs. The gable ends located to the north and south are mainly brick built (Figure 11). This building is in a good state of repair with no potential bat access points. There was no accessible roof void in the building.

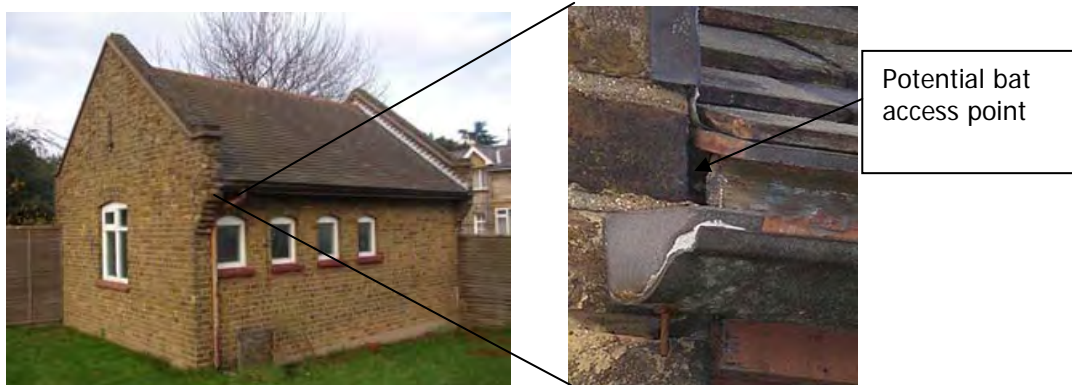
Figure 12 Building G

This building is brick built with a tiled pitched roof with gable parapets on the eastern and western elevations (Figures 12 and 13). The tiles and brickwork are in a good state of repair

with no obvious bat access points. The windows are sealed with no bat access points. On the south-eastern corner of the building there is a hole in the soffit box, no evidence of bat use was recorded, however this hole could potentially provide suitable bat access.

Figure 13 Close Up of Potential bat Access Point

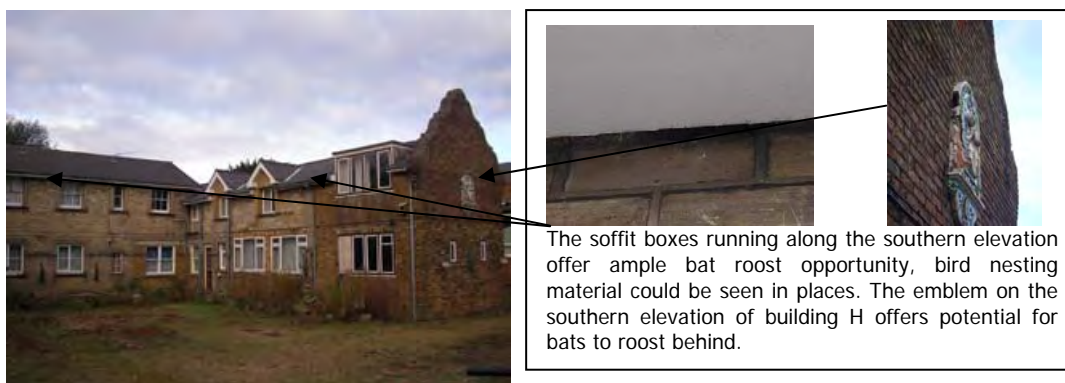
Figure 14 Building H

This is an 'L' shaped building consisting of a pitched roof design with gable ends to the northern, southern and western elevations (Figures 14, 15 and 16). The roof is clad with slates with a combination of pitched and flat roofed dormer windows. On the southern elevation there is a parapet at the gable end. Soffit boxes run along the length of the building on both elevations. Access to the roof void was not possible; however potential bat access points are plentiful with large gaps between the soffit boxes and the main wall of the building. A ceramic emblem on the southern elevation was broken, offering the potential for bat access behind the plaque.

Inset Figures 15 & 16 Potential Roost Sites

During the May 2007 survey a single bat dropping considered to be from a pipistrelle bat was recorded beneath a gap where the soffit box meets the main wall on the eastern elevation.

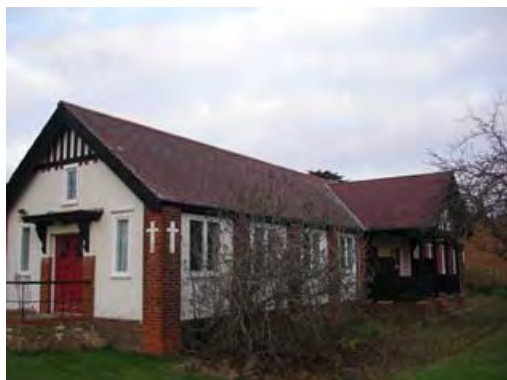
Figure 17 Building I Showing Eastern Entrance Porch

This building is of brick built pitched roof design with gable ends to the western and eastern elevation. The main roof is internally lined leaving a small roof space that was not accessible to the surveyor. Midway along the eastern elevation lies an entrance porch with a pitched roof which forms a junction with the main roof, this area has a roof void within it. The northern elevation of the building has a brick built lean-to which houses the boiler room, and allows access to the basement area of the building (Figures 17, 18, 19 and 20).

The roof void, basement and external elevations of the building were investigated, and although no evidence of bat activity was recorded there are numerous roosting opportunities for bats. Gaps allowing bat access are located along the ridge tiles where mortar is missing and along the southern elevation where the soffit box meets the main wall. A small gap in the boiler room extension could allow access to the basement for bats to hibernate. However, no evidence of bats was recorded within the basement.

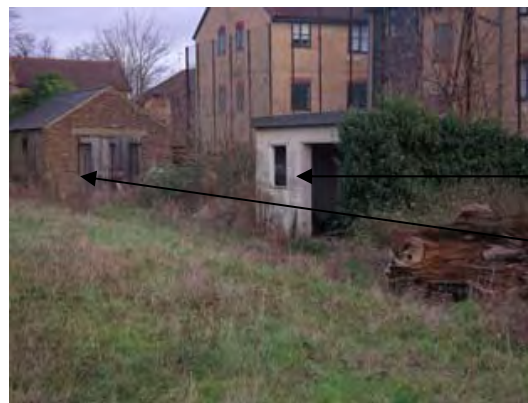
Figure 21 Buildings J and K

Building J is an open fronted brick built lean-to with a flat felt covered roof (Figure 21). The building was thoroughly investigated, however no evidence of bats was found and the

Buildings J and K. Building J is the white building in the fore ground, building K is the pitched roof building in the background.

Building K comprises a brick built garage with a pitched slate roof (Figure 21). There are no soffit boxes; however fascia boards are present which appear to be in a good state of repair. The southern elevation is covered by a vigorous growth of ivy. Internally the building is open plan with no roof void. The roof area is heavily infested with cobwebs. A few pieces of farm machinery are parked within the garage. The entire building was thoroughly surveyed and no evidence of bat activity was recorded.

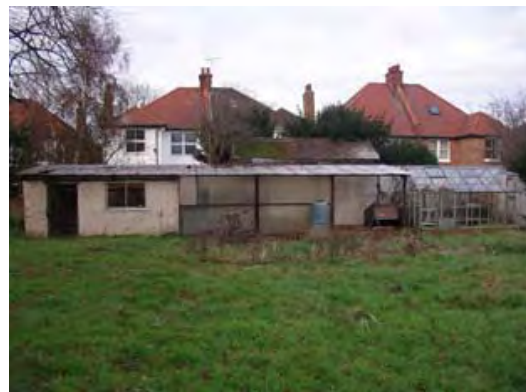
Figure 22 Buildings L

These temporary buildings comprise a green house, an open fronted porch area and shed (Figure 22). The only building considered to be of a suitable design to offer bat roost potential is the shed. However the shed is in a poor state of repair with broken windows and as a result it was drafty and generally unsuitable for roosting bats.

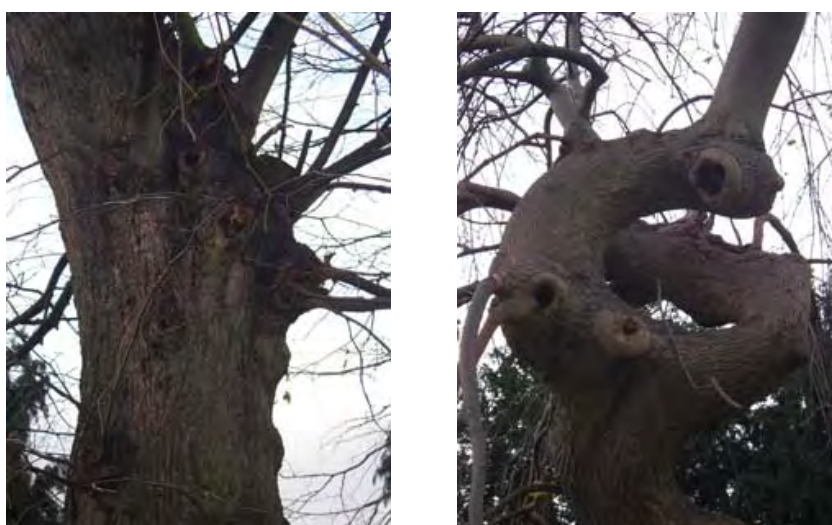
Figures 23 and 24 Trees with Bat Roost Potential

A number of trees are present on the site that provide potential for bats to roost due to the presence of holes, cracks, splits within the bark, loose bark etc. These trees include two cherry *Prunus* sp. and two ash *Fraxinus excelsior* that have a number of holes and cracks (Figures 23 and 24). A line of lime *Tilia platyphyllos x cordata* trees in the north-west of the site appear to provide suitable bat roost potential, although on closer inspection these trees lacked features that would be suitable. Two large cedar trees located adjacent to the site entrance gates have a number of cracks and crevices that may be utilised by roosting bats, however, a full investigation was not possible due to the height of these trees. The locations of trees with bat interest are shown on Map 1.

It is recommended that all buildings and trees with bat potential on site are subjected to detailed emergence surveys to confirm presence/absence of roosting bats through the 2008 survey season. Such surveys would need to be carried out between late May and late September.

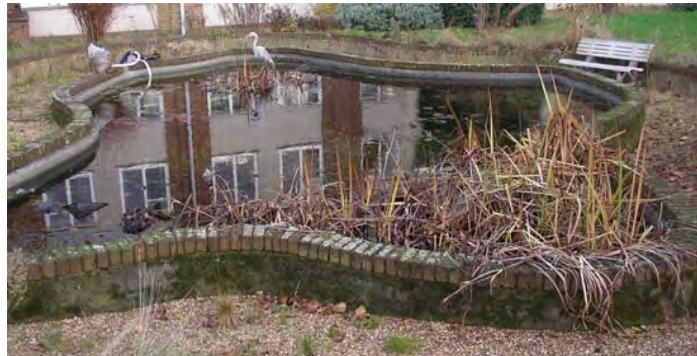
Figure 23 Ornamental Pond in Grounds

There are two ponds present on site, one is a very small ornamental pond, which is concrete sided and considered unlikely to support a population of GCN. The second pond is larger (Figure 23) with emergent vegetation in the form of white water lily *Nymphaea alba* and yellow flag iris *Iris pseudacorus*. Canadian pond-weed *Elodea canadensis* is the dominant submerged vegetation. The depth of the water prevented an examination of the centre of the pond. However, all of the vegetation around the edge of the pond was investigated for newt eggs. Following completion of the egg search the pond was netted in an attempt to capture any amphibians present. No newt eggs of any species were recorded and no newts were recorded during the netting session. However, it should be noted that only one survey was carried out.

Although it appears unlikely that GCN would breed in either of the two ponds present on site, it is recommended that presence/absence surveys are carried out to prove this beyond

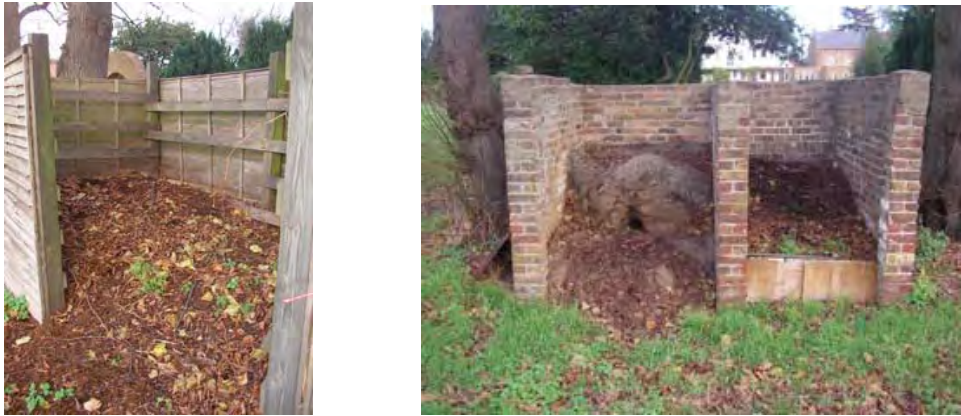
Figure 24 and 25 Compost Heaps at the Western End of Grounds Providing Suitable Reptile Habitat

Areas of grassland throughout the site have been left un-managed for approximately three and a half years, and are considered to offer suitable habitat for the common reptile species such as common lizard *Lacerta vivipara*, slow-worm *Anguis fragilis* and grass snake *Natrix natrix*. Two compost heaps were identified as providing potentially suitable sites for breeding and hibernating reptiles (Figure 24 and 25).

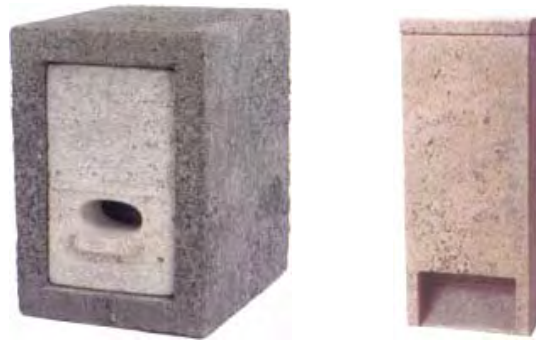
Figure 27 Schwegler N27 and number 750/6 Roost Units

- Roost units, such as the Schwegler N27 and number 750/6, should be incorporated into the structure of the buildings (Figure 27). Roost units are built into the brick work, concrete, or cladding of the building and should be incorporated into the southern elevation. Depending on the number of bats present it may be appropriate to install 20-30 of these units so as to provide a wide range of roosting opportunities.

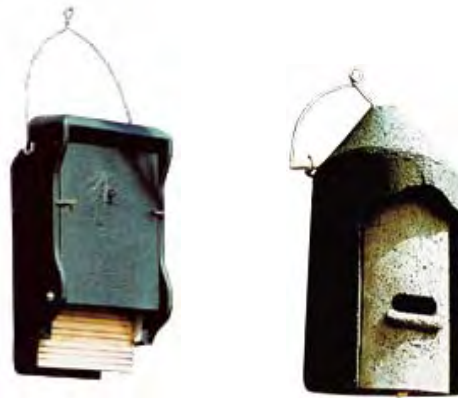
Figure 26 Schwegler 1FF and 2F Bat Boxes

- A total of 20 Schwegler boxes or similar should be erected on the south elevations of buildings and trees around the site. The 1FF box (Figure 26) has been shown to be successful, however it may be advantageous to include a number of 2F boxes, and to vary the elevation of the boxes to provide a variety of roosting opportunities. The

boxes would be sited as high in trees and on buildings as possible so as to minimise disturbance, yet still be accessible for inspection and monitoring.
